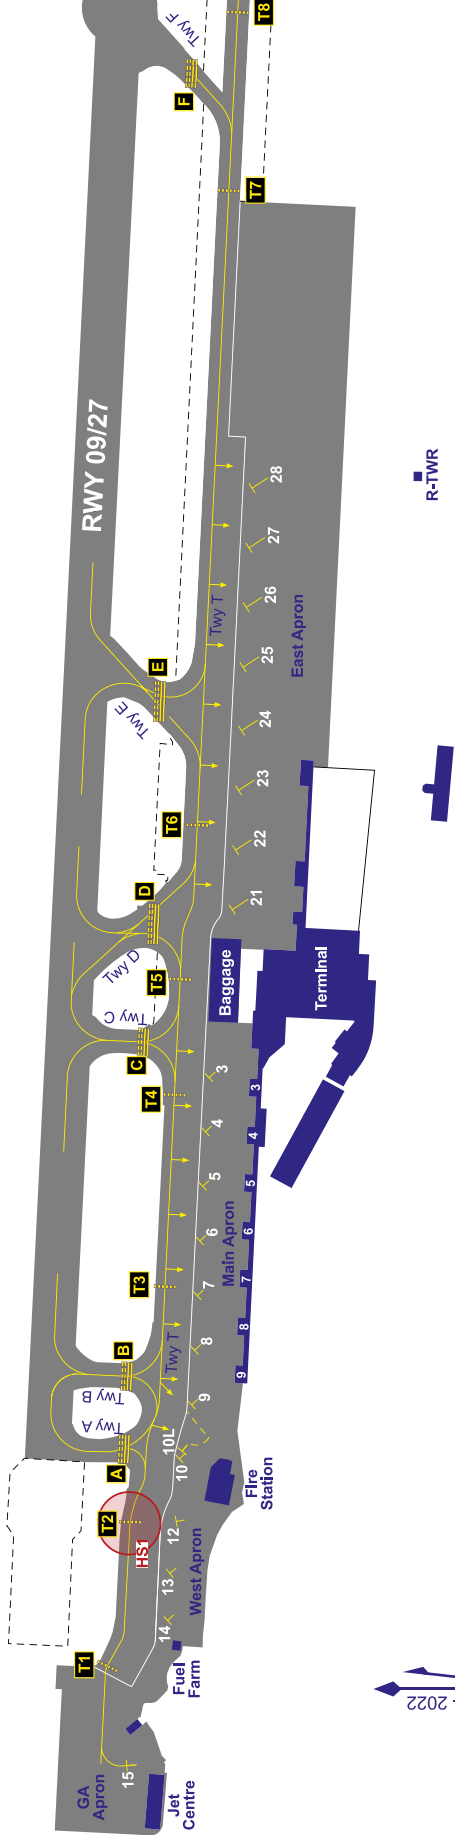
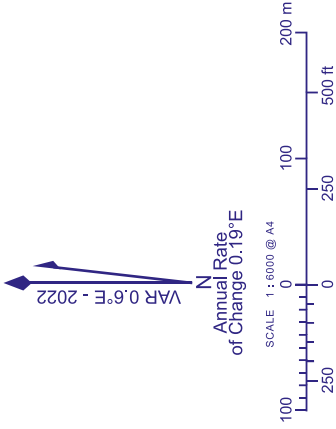
**Hot Spots**  
**HS1**  
Tango 2 is a short taxi from the GA Apron. Hold Point markings are in close proximity to other taxiway/island markings.
